## ES.1 INTRODUCTION AND PURPOSE

The overall purpose for preparing this study is to identify how Drop Structure 2 could potentially be made safer, while still achieving its flood control requirements and benefits. This study was commissioned by the Contra Costa County Flood Control and Water Conservation District (FC District) to provide information regarding improving the safety of the WCFCCS and Drop Structure 2 to guide future management decisions.

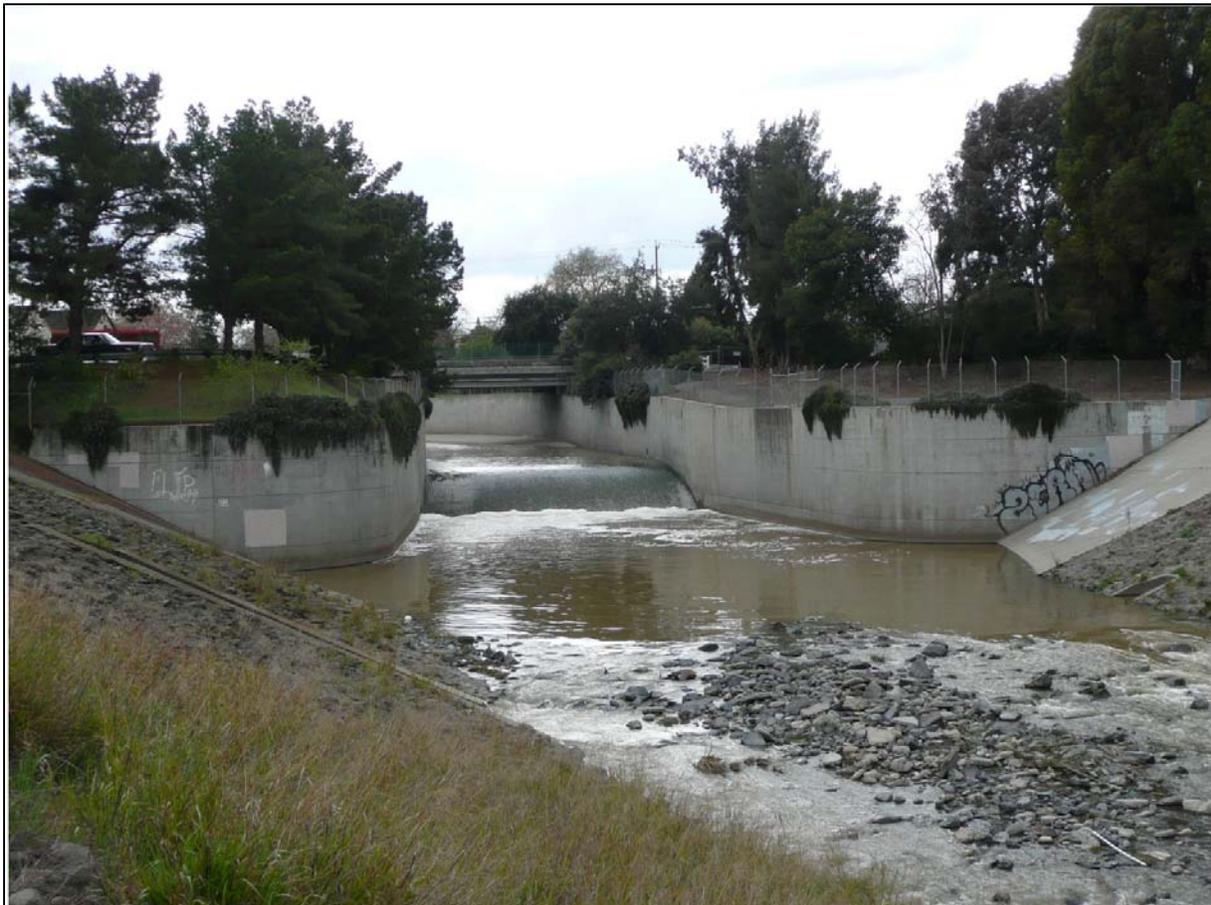
Figure ES-1. Drop Structure 2 at a Relatively Low Flow

At Drop Structure 2, just downstream of Bancroft Road, the water flows from the upstream concrete channel over a 20-foot drop, flows through a stilling basin (to slow the water down) and then up-wells by about 8 feet into the downstream earthen and rock lined channel. This results in an overall drop of 12 feet. In the stilling well, the water is very turbulent, and swirls around in a vertical loop, but it eventually leaves the stilling well and enters the downstream channel. The swirling of the water in the stilling well is called a submerged hydraulic jump or simply a hydraulic. The water flowing through this hydraulic can flow through the vertical loop several times before it is pushed out of the stilling well and flows downstream. This vertical flow loop can also entrain a person and hold them underwater for a dangerously long time.

Eight people are reported to have drowned in the Walnut Creek Flood Control Channel System (WCFCCS), which includes Drop Structure 2 (shown in Figure ES-1) since the WCFCCS was constructed in the 1960s and 1970s. Additionally, one fire fighter was injured in 2010 while rescuing a victim from the channel.
